WATER RESOURCES ASSESSMENT

Overview

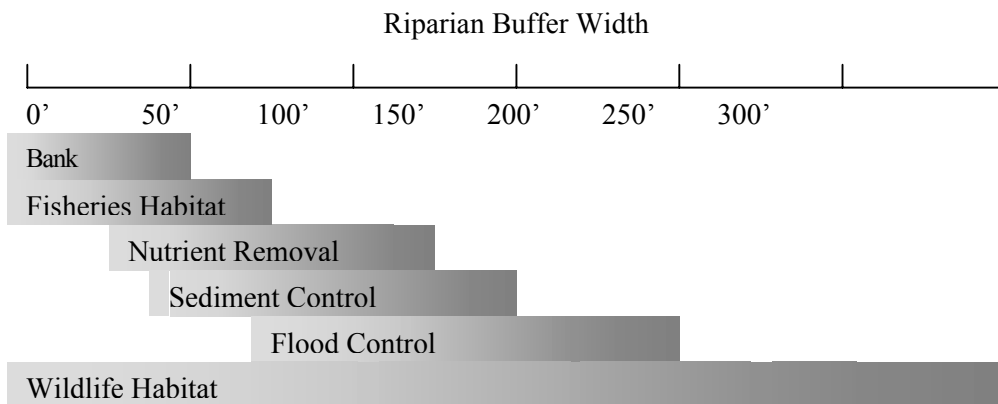
Figure 3-1. Recommended Riparian Buffer Widths

have shown that the wider and more substantial a riparian zone is, the better it can perform these functions (Klepproth 2000). Figure 3-1 shows recommended riparian zone widths for bank support, fisheries habitat, nutrient removal, sediment control, flood control, and wildlife habitat.

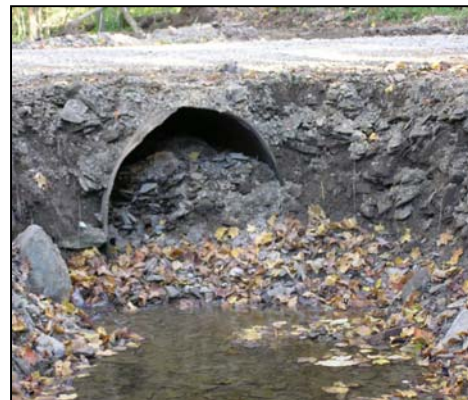
An inadequately designed culvert and endwall from a Buck Run tributary filled with sediment after a flood in 2004.

Examples of improvements made through the Dirt and Gravel Road Program include grade breaks, french mattresses, headwall and endwall construction or improvements, and use of driving surface aggregate. Grade breaks increase the road elevation on a downhill slope, causing water to flow off the road surface and preventing erosion of road material. French mattresses are structures built under a roadway through which water can fully pass, allowing a non-erosive discharge of water. Headwalls and endwalls are walls built around culvert openings that can be modified to withstand higher flow capacities. Driving surface aggregate is a road surface containing fine particles that can be used in place of more common applications containing silt and clay. Unlike silt and clay, the fine particles settle out and can have less negative effects on aquatic life (Penn State). Figure 3-4 shows priority dirt and gravel roads within the Buffalo Creek watershed.

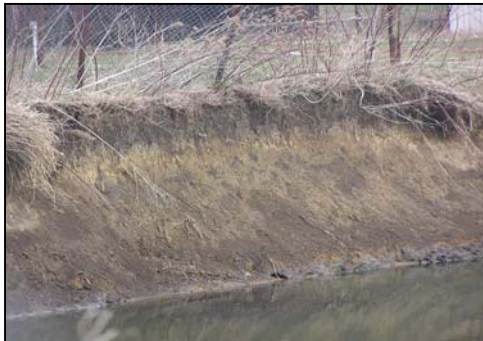
Severe erosion along a section of Buffalo Creek, resulting in significant loss of streambank each year

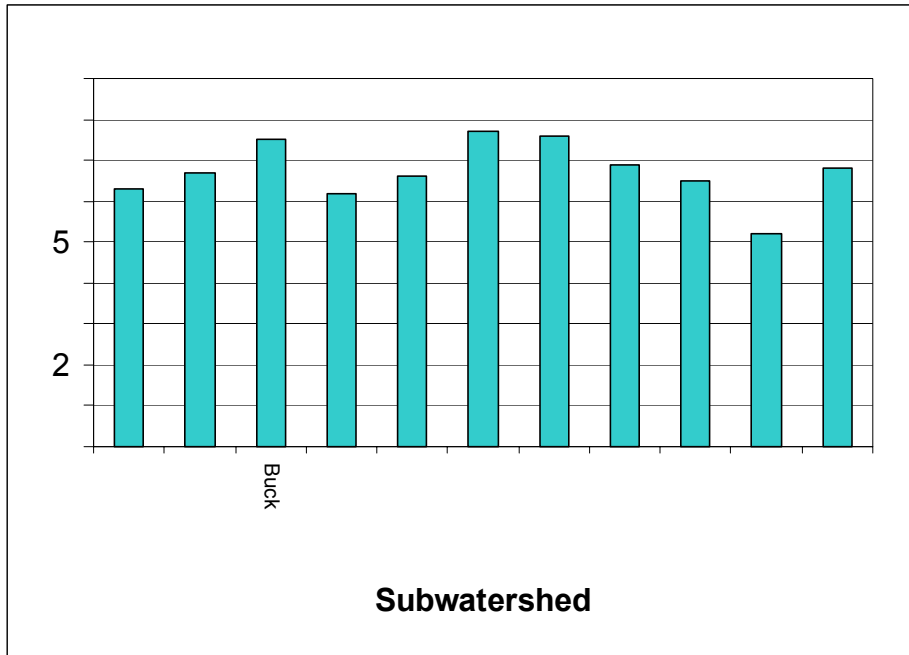
Figure 3-9 shows the streams sampled during the visual assessment survey. Each stream assessed is given a different color based on its rating. Figure 3-8 shows the average stream score within each subwatershed. Scores within many of the subwatersheds varied greatly, and percentage area of each stream scored was not considered in the averaging. The subwatershed with the lowest average score was Buffalo Creek East, and the subwatershed with the highest score was Lower Buffalo Creek.

higher score indicates better stream health. within each subwatershed. A

The lowest scoring category was “embeddedness,” an indicator of sedimentation. Of the 11 subwatersheds, six had embeddedness as the lowest scoring category and two had embeddedness as the second lowest scoring category. The most common second lowest scoring categories were “instream fish cover” and “bank stability.” Table 3-15 gives results for each parameter.
